Fish Lake 2 Power Station Design

2023-2024 Business Case #39

ATCO Electric Yukon
Fish Lake 2 Condition Assessment
Fish Lake, YT

Technical Report
Condition Assessment and Options Analysis

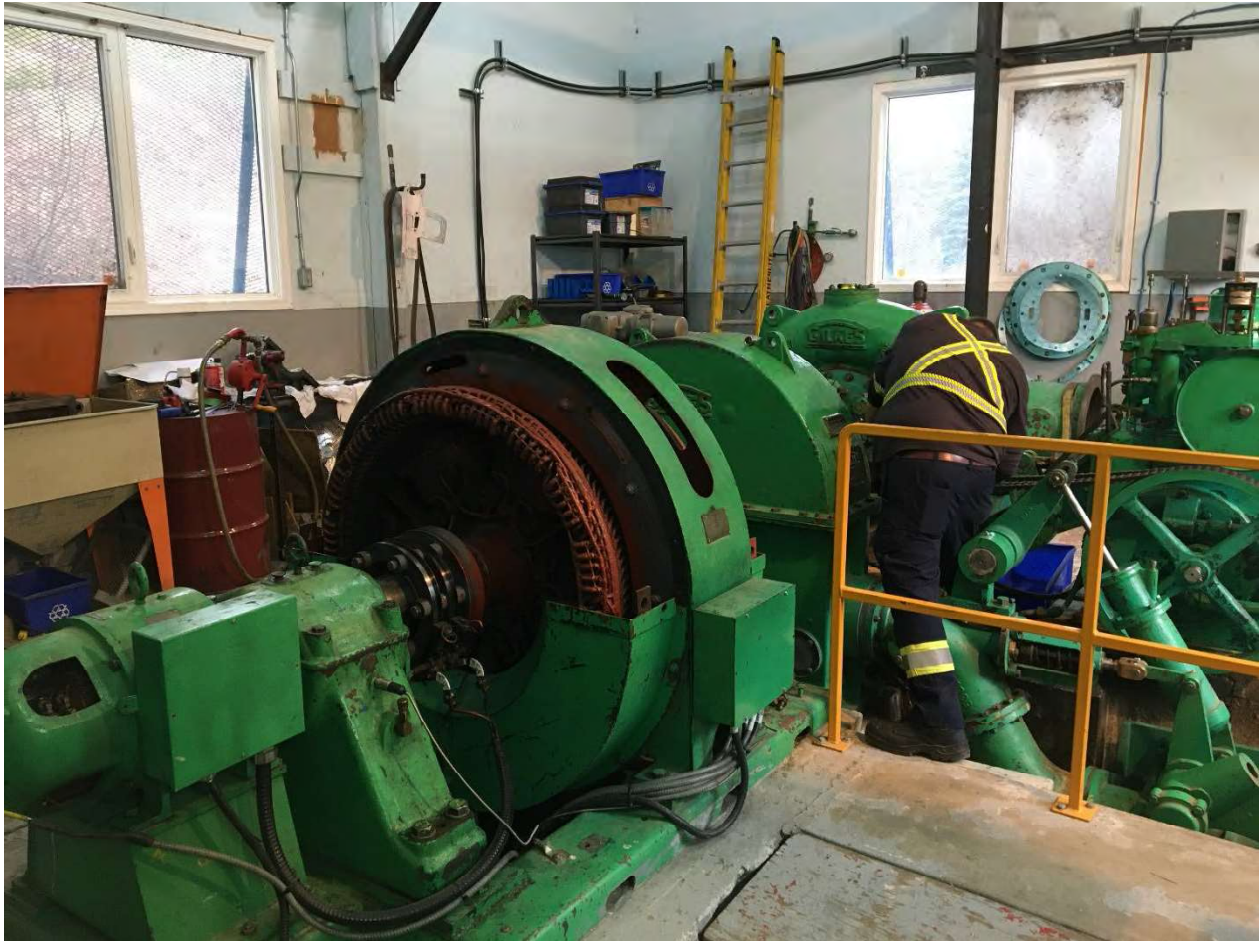
Figure 1: Turbine and Generator

The Fish Lake 2 generator is a horizontal, 812 kVA, 1200 RPM, 2300V, 3 phase Westinghouse generator with an 800 BHP (600kW), 200 ft head Gilkes Francis hydro turbine. The unit was installed in Fish Lake 2 in 1954. It is presently 68 years old and maximum output is reported to be 480kW.

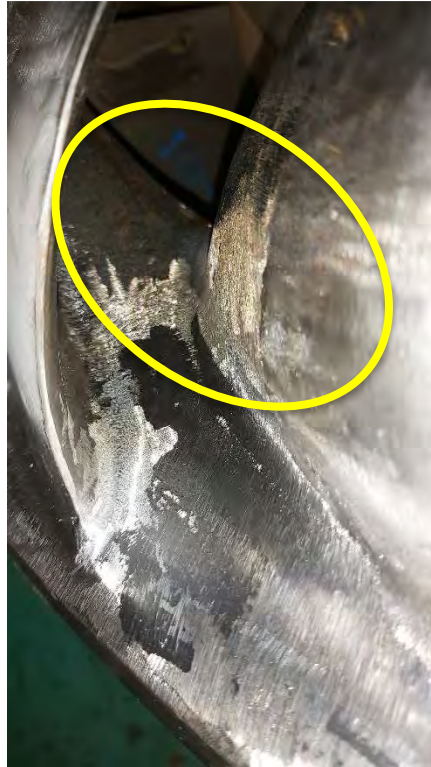
- Runner is showing frosting or cavitation on the suction sides, signifying that the flow is a little too high (as max output is below rated O/P this means head is lower than rated head – it is 6% below rated head);
- Stay vanes are very rough, high friction losses, misshaped leading edges;

Figure 2: Runner Suction Side Cavitation (expansion too severe)

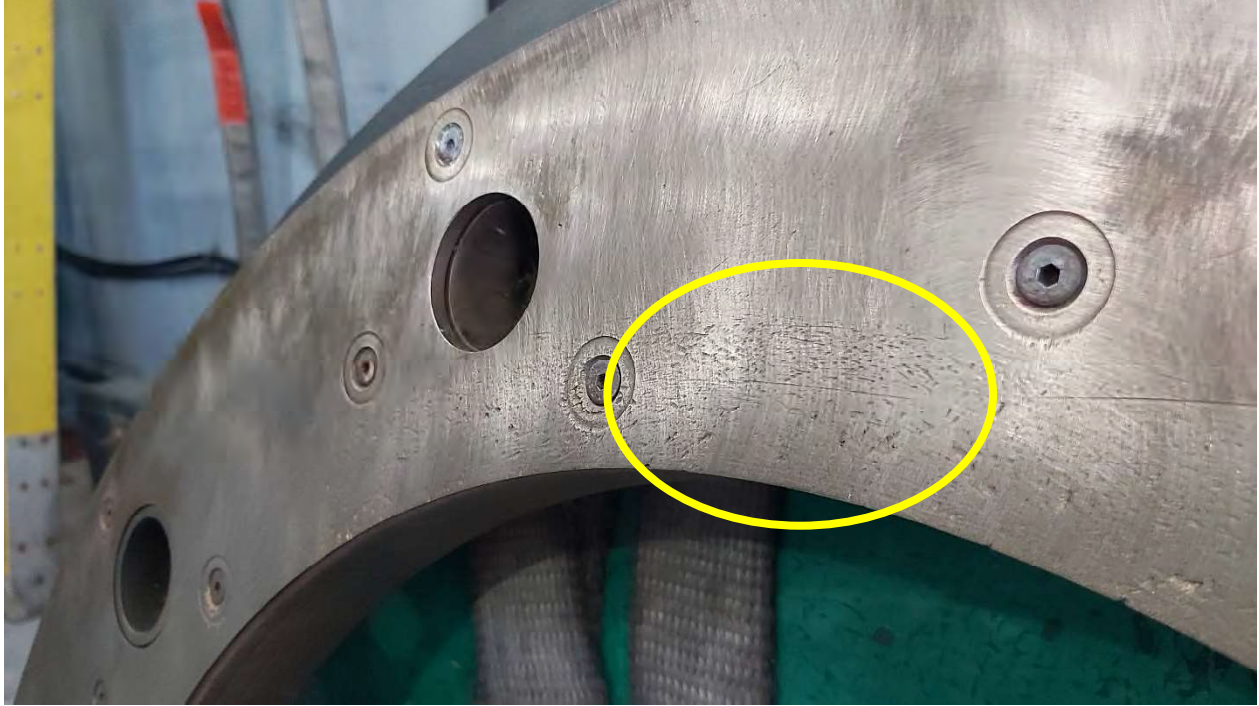
- Wicket gates show signs of leakage past lower wear rings, the upper gap could not be seen but measured 0.0015" to 0.014". The worst areas being the trailing edges. Post visit/annual maintenance TW informs us that the gap is now reduced to 0.4mm;

Figure 3: Lower Wear plate and Band seal Damage (Cavitation)

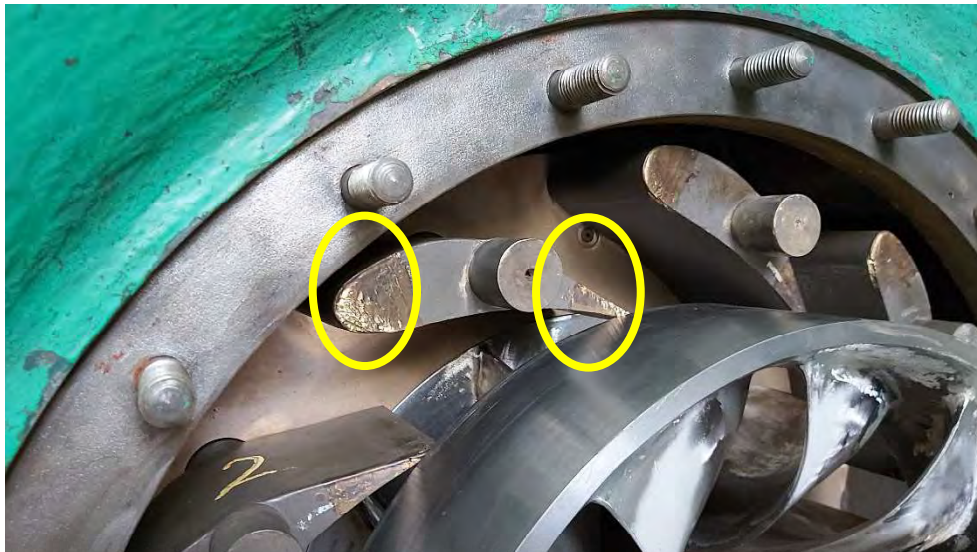
Figure 4: Wicket Gate Damage

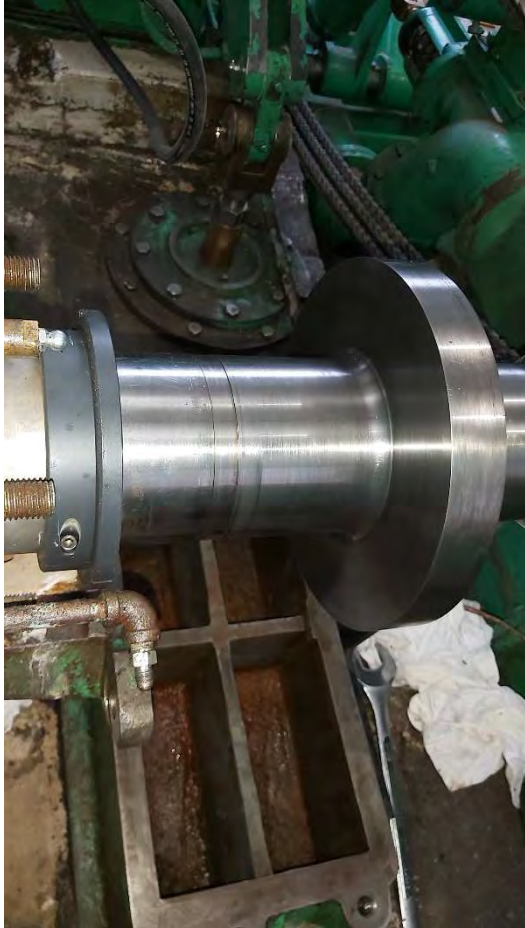
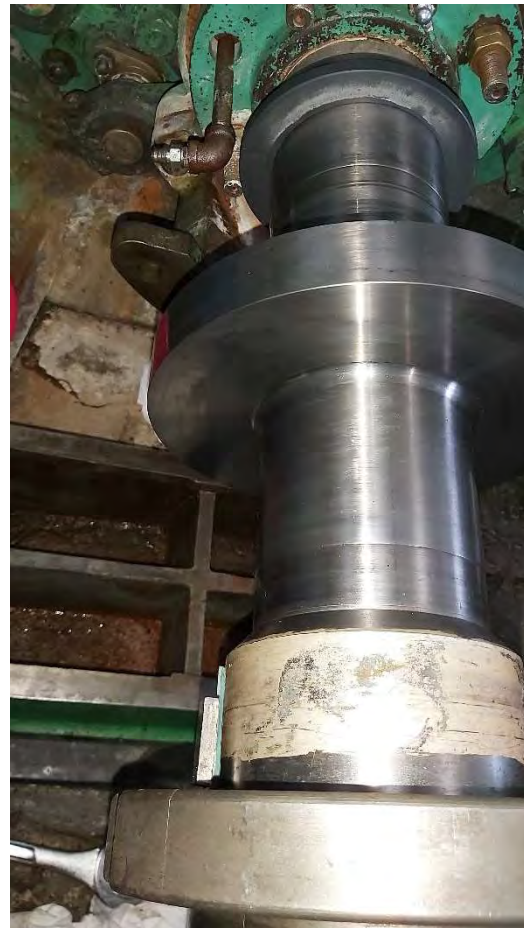
Figure 5: Turbine Journal Bearing Shaft Scoring

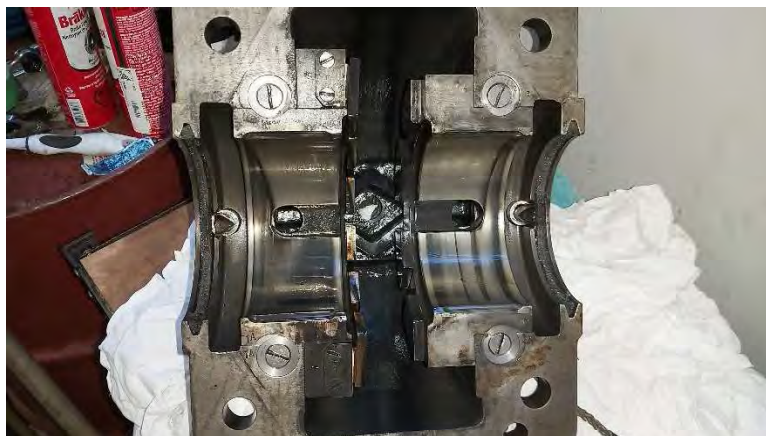
Figure 6: Turbine Journal Bearing Minor Wear

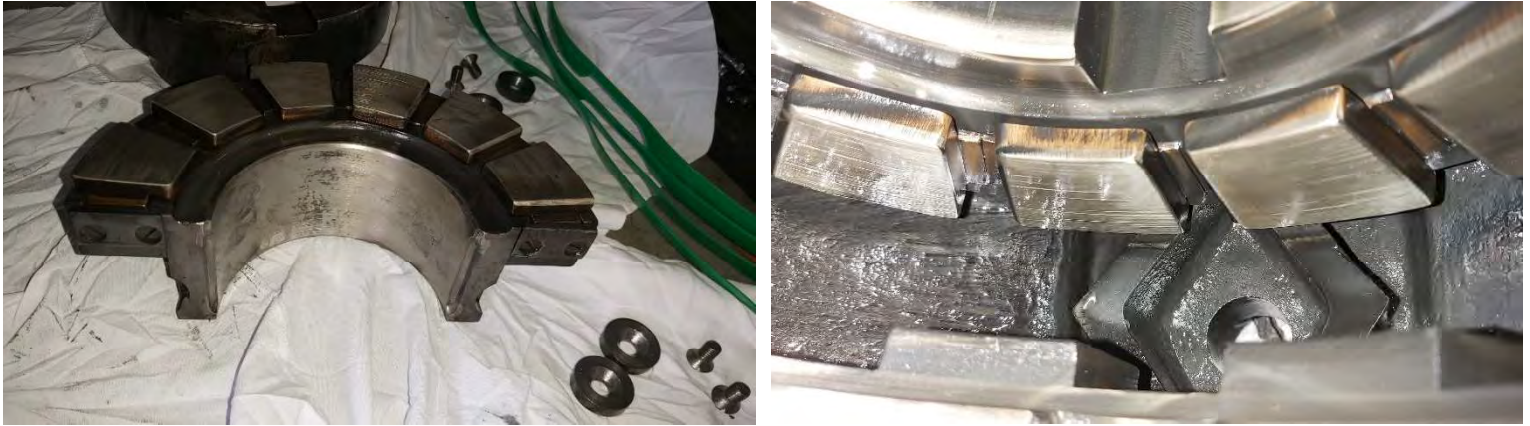
Figure 7: Thrust Pad Damage

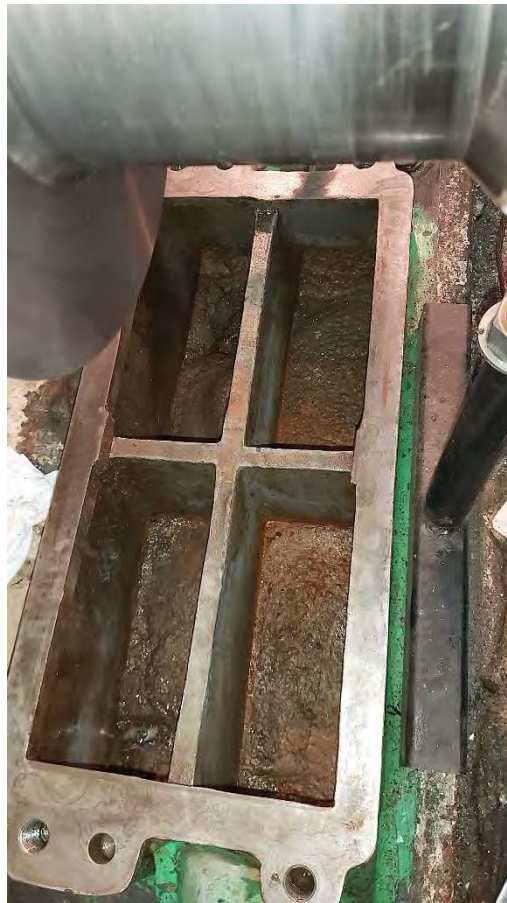
Figure 8: Turbine Bearing Pedestal Hole to Ground

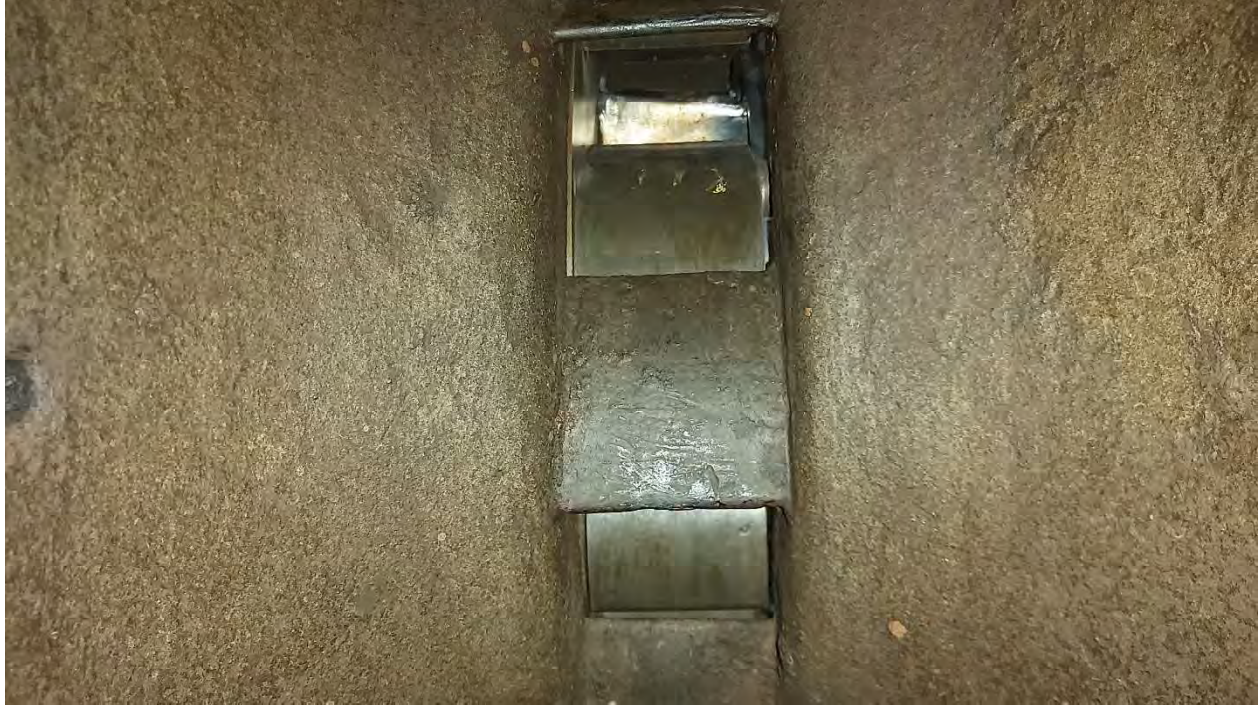
Figure 9: Scroll Case and Stay Vane High Friction Condition

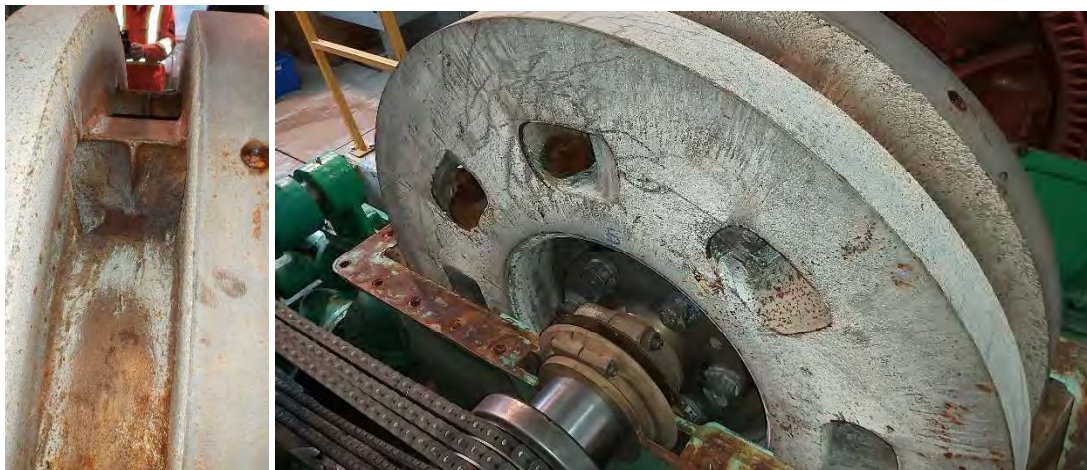
Figure 10: Brake/Flywheel Damage

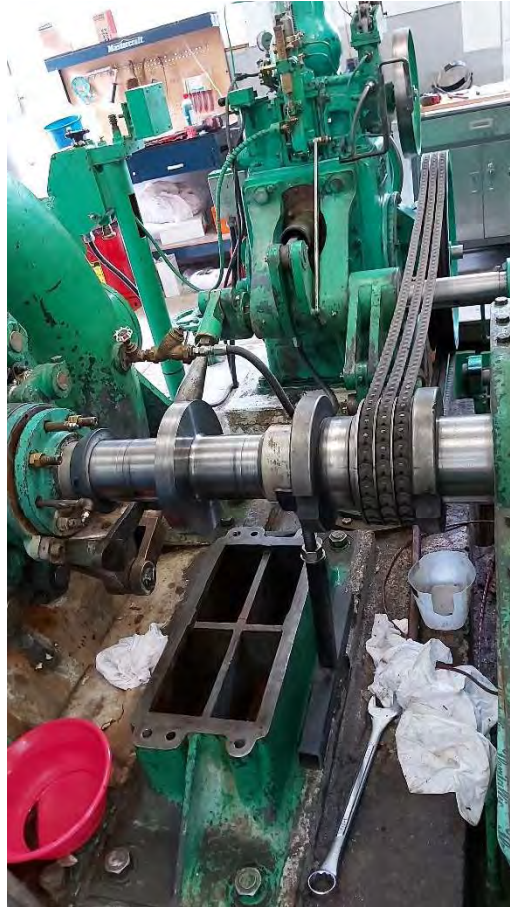
Figure 11: Gilkes Governor Belt Drive (Speed Indication)

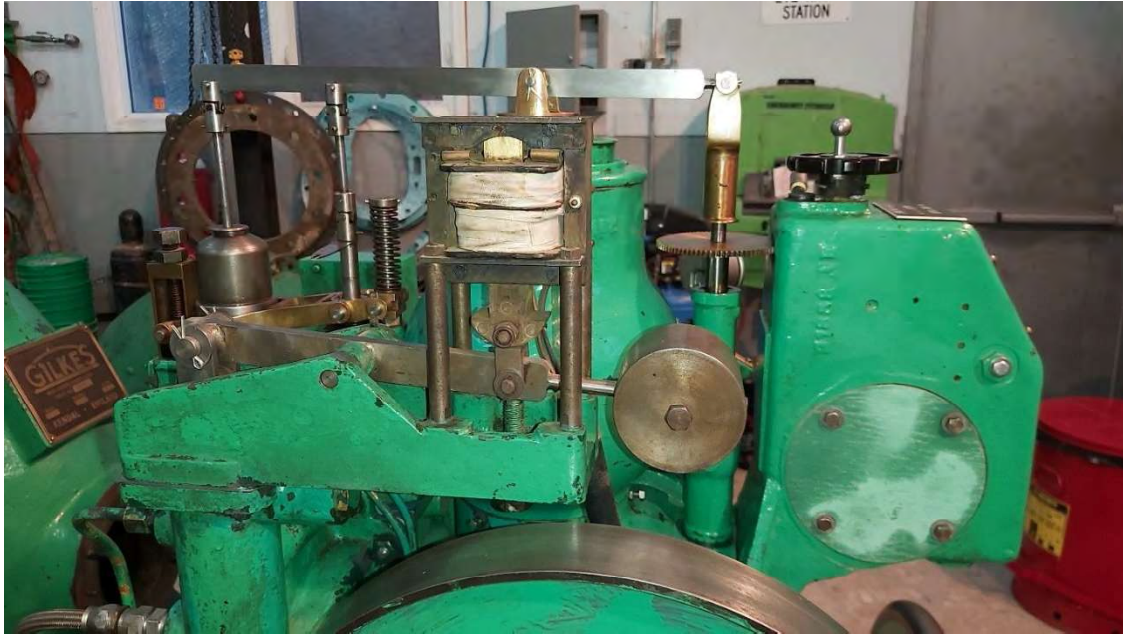
Figure 12: Gilkes Governor Head LHS

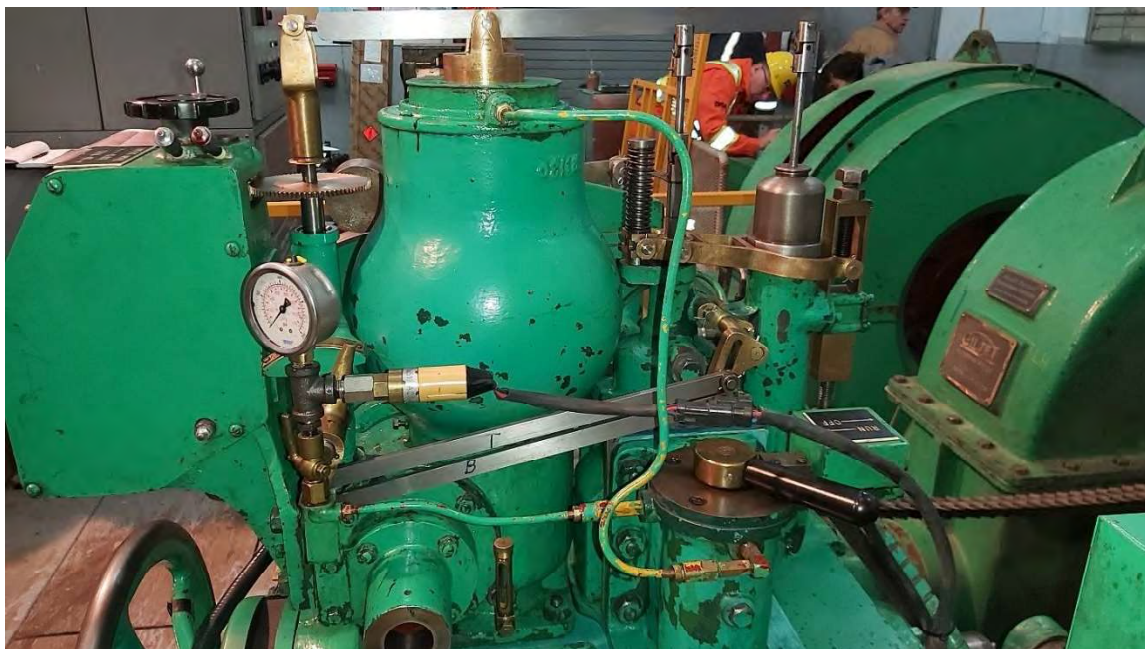
Figure 13: Gilkes Governor Head RHS

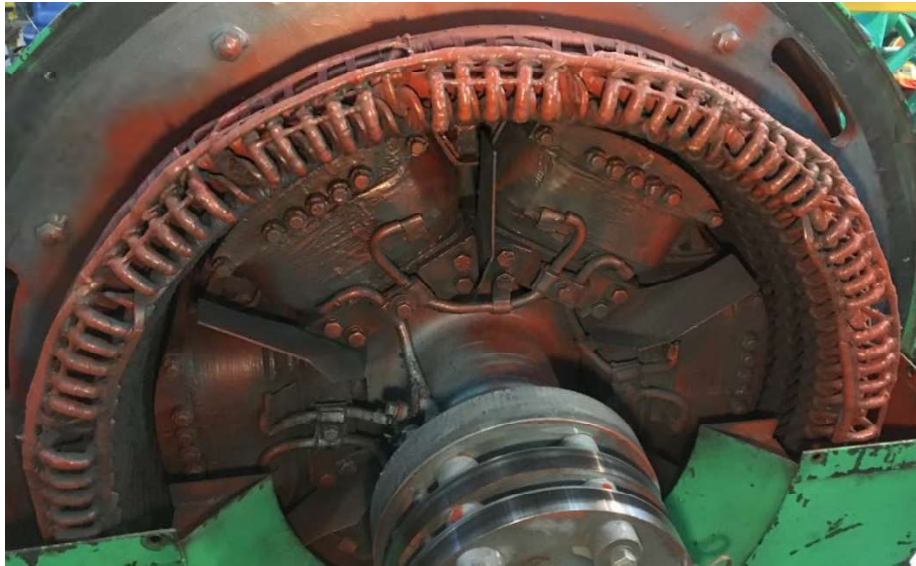
appear to be lashed tightly and are in good condition with no discoloration, dusting, cracking of the insulation, or flaking of the grading paint.

According to the Maven Report the stator was rewound in 2000 and appears to still be in good condition. Contributing to the condition is no doubt the fact that the generator has been operated approximately 25% below its maximum nameplate rating for most of its life.

Figure 11: Generator Windings

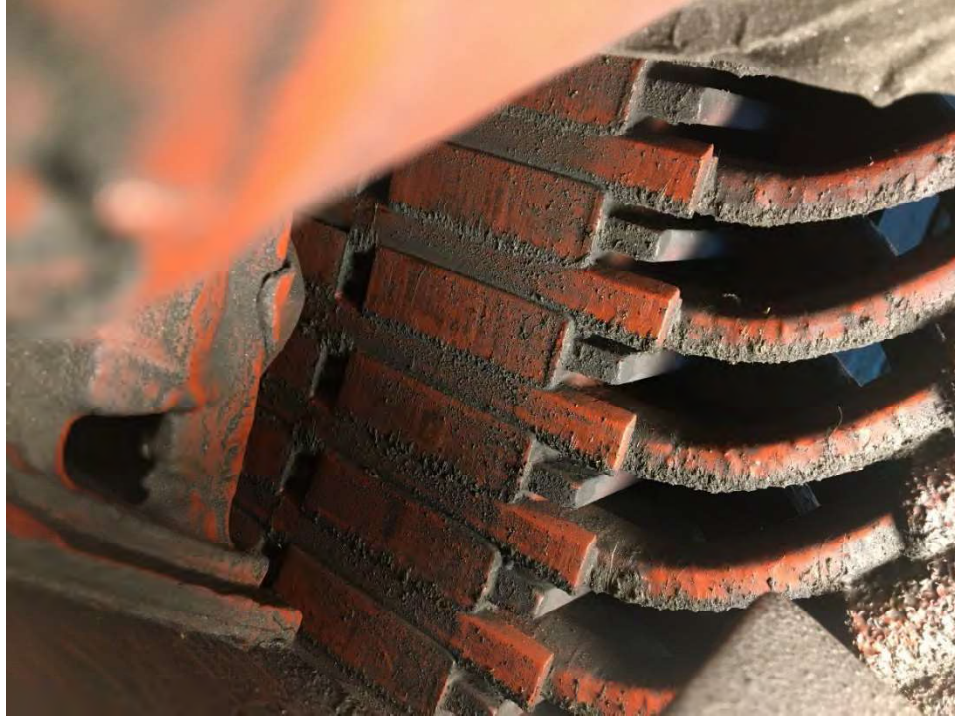
Figure 12: Stator and End Turns with Carbon Dust Buildup

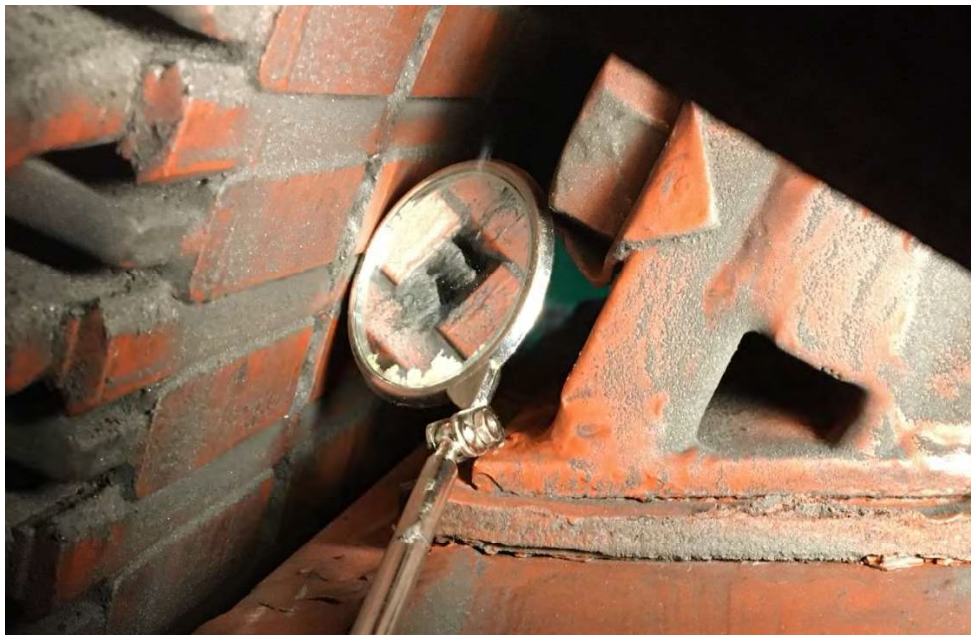
Figure 13: Inspection Partially Obstructed Stator Slot

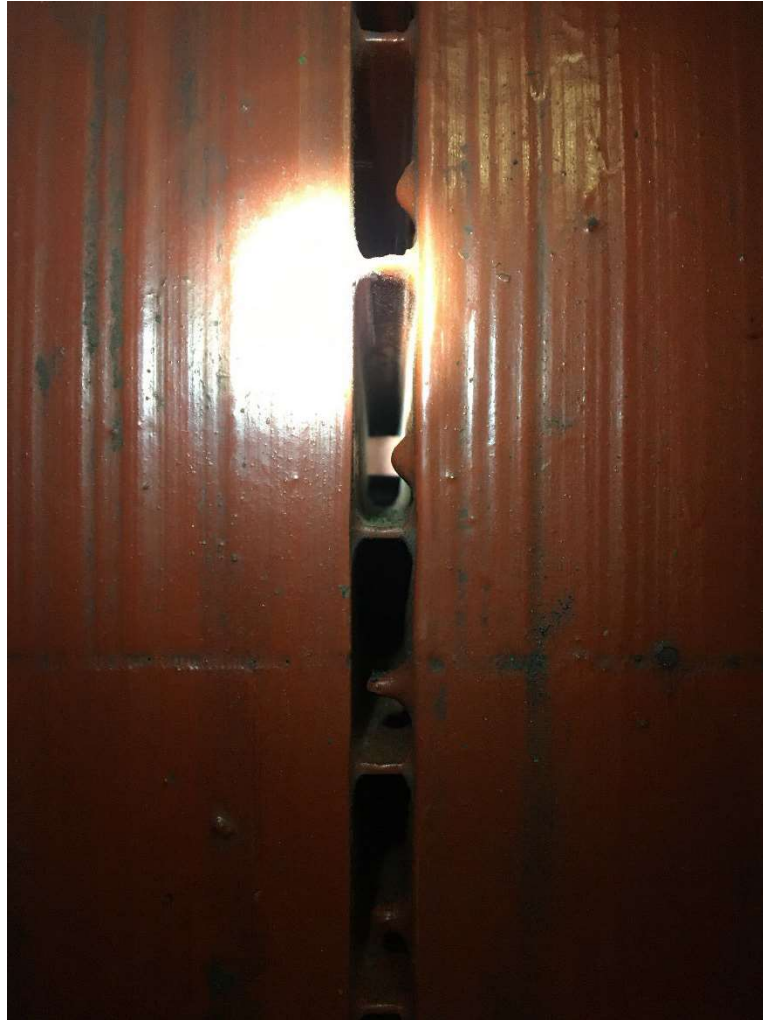
Figure 14: Stator Air Slots on Outside

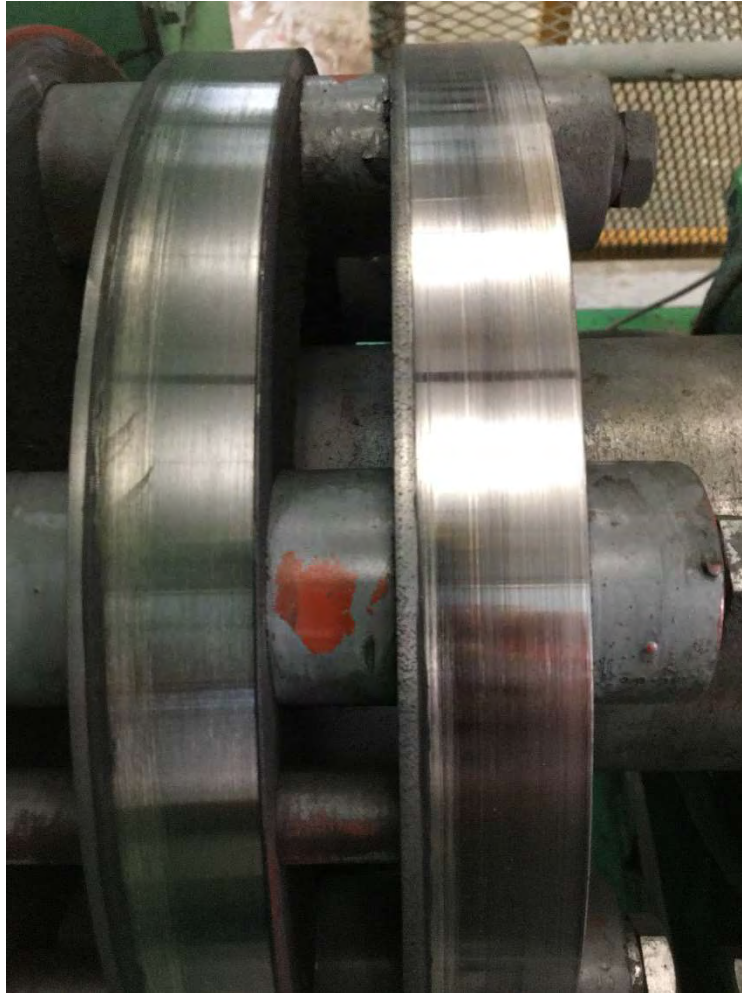
The main slip rings are smooth but have some streaking. The brush holder is solidly mounted and holds four brushes per ring. The frequency of brush change out needs to be confirmed by ATCO. BBA recommends cleaning to remove the streaking.

Figure 15: Main Slip Rings

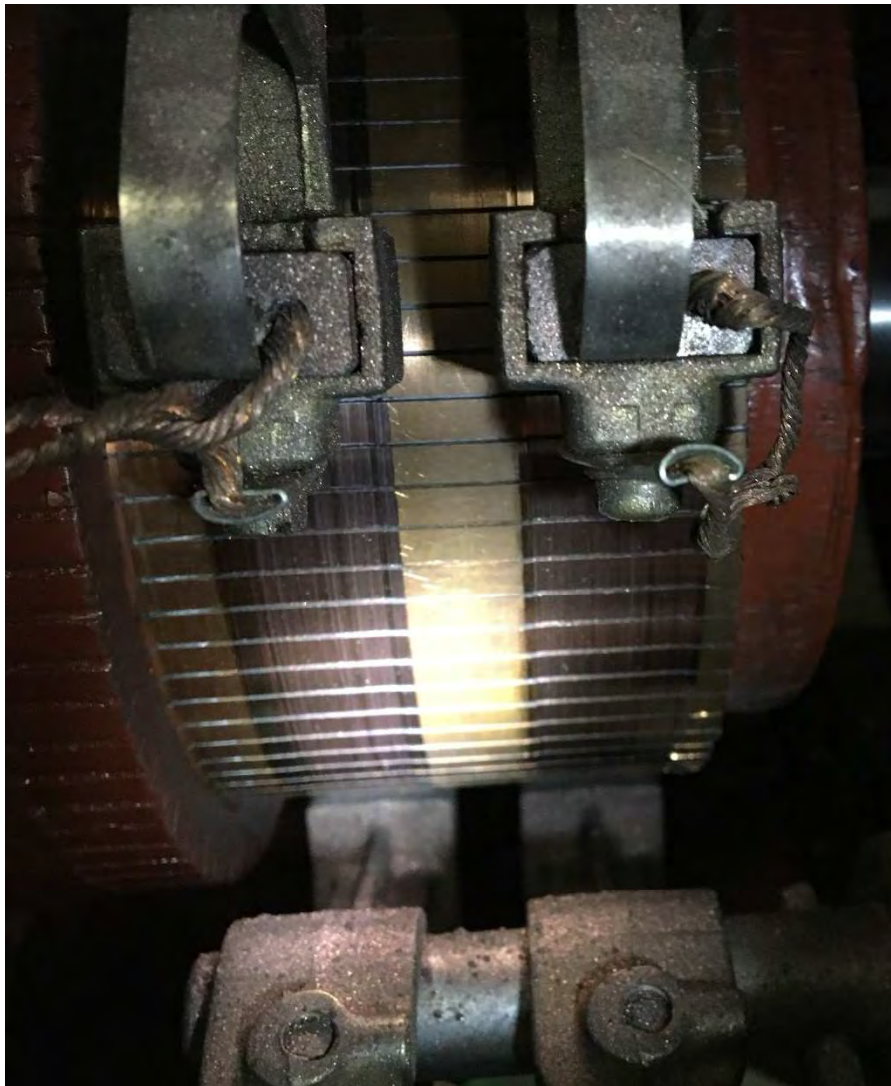
The direct coupled rotary DC generator used to supply power to the generator field, would generally have a lifespan of about 40 years before requiring a full rehabilitation. This unit is nearly 69 years old and although the commutator was resurfaced in 2014 (per the Maven report) there is no evidence that it has had a complete overhaul.

Figure 16: DC Generator Commutator

The Maven Report suggests that different brush densities and adjustment of the brush holders be further investigated. In addition, each time the commutator needs resurfacing the work needs to be synchronised with a suitable unit outage window.

To eliminate brush and commutator maintenance and extend life, the removal of the DC generator and replacement with a new static exciter should be considered. This would tie in nicely with a P&C upgrade.

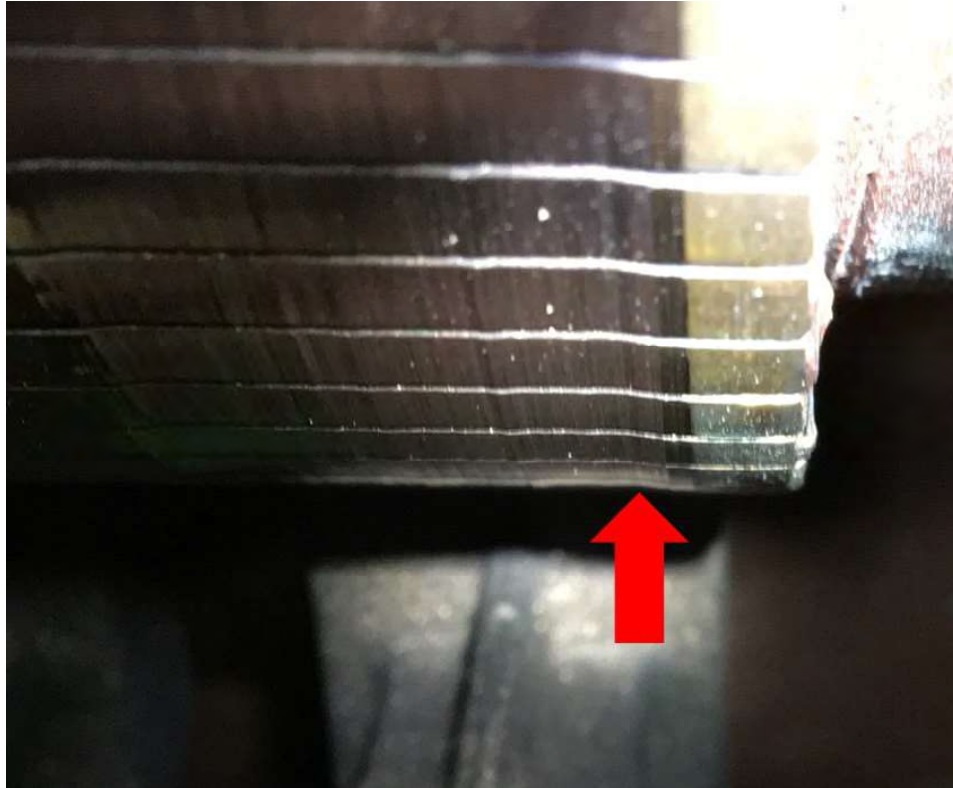
Figure 17: Groove Worn in Commutator

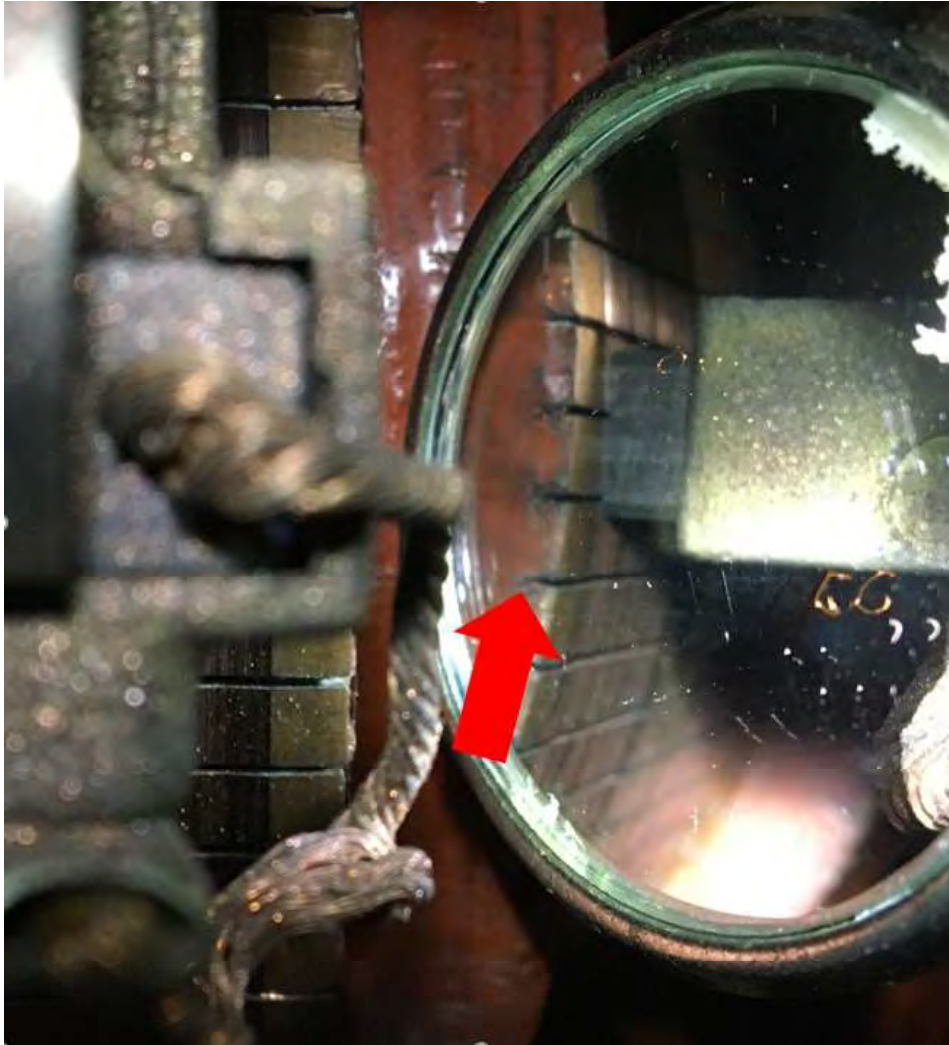
Figure 18: Commutator Remaining Surface (~3 to 4mm)

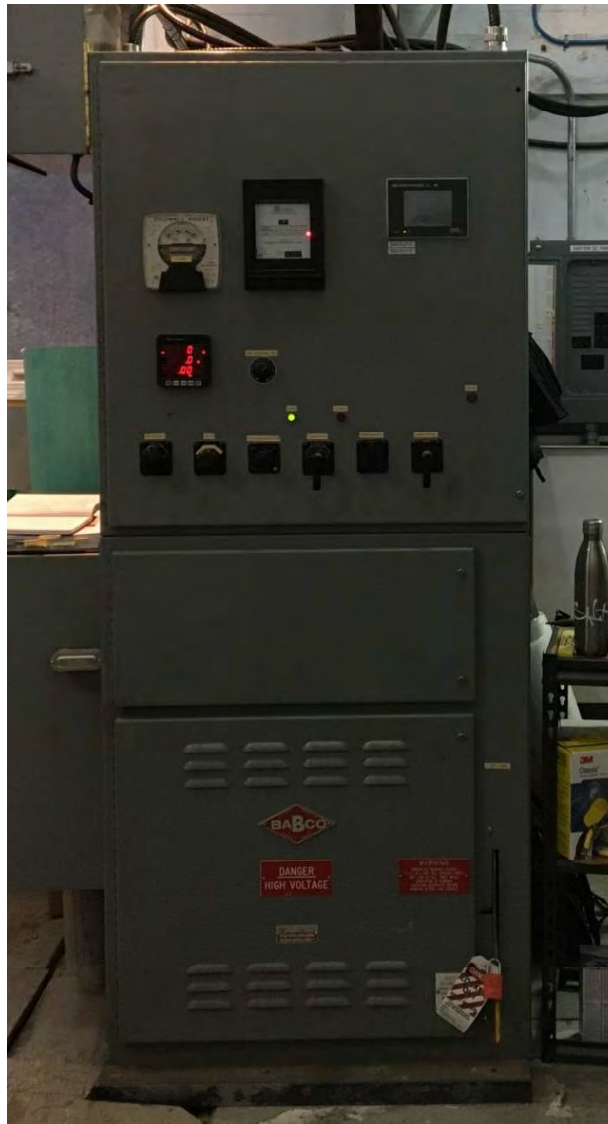
The switchgear and P&C are in a combined cabinet with a 4kV vacuum circuit breaker in the bottom compartment, CTs and PTs in behind and the P&C components isolated from the MV gear in their own cabinet above. It is worth noting that this equipment appears to have been installed in approximately 1999 and is now 23+ years old.

The position and location of the generator controls adjacent to the running equipment and directly above the generator circuit breaker poses somewhat of a safety risk to the operator.

Figure 19: P&C and SWGR Panel

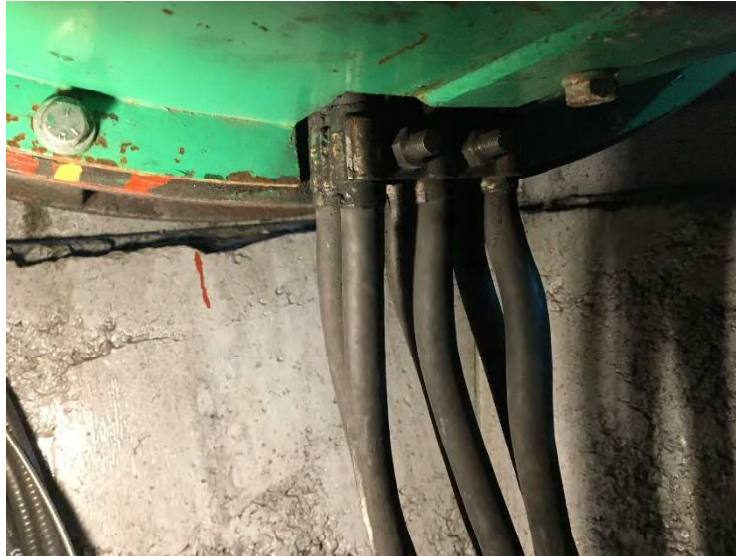
The MV cables appear to have been replaced since the original installation, most likely in 1999 when the new switchgear was installed.

Figure 20: MV Cables Under Generator

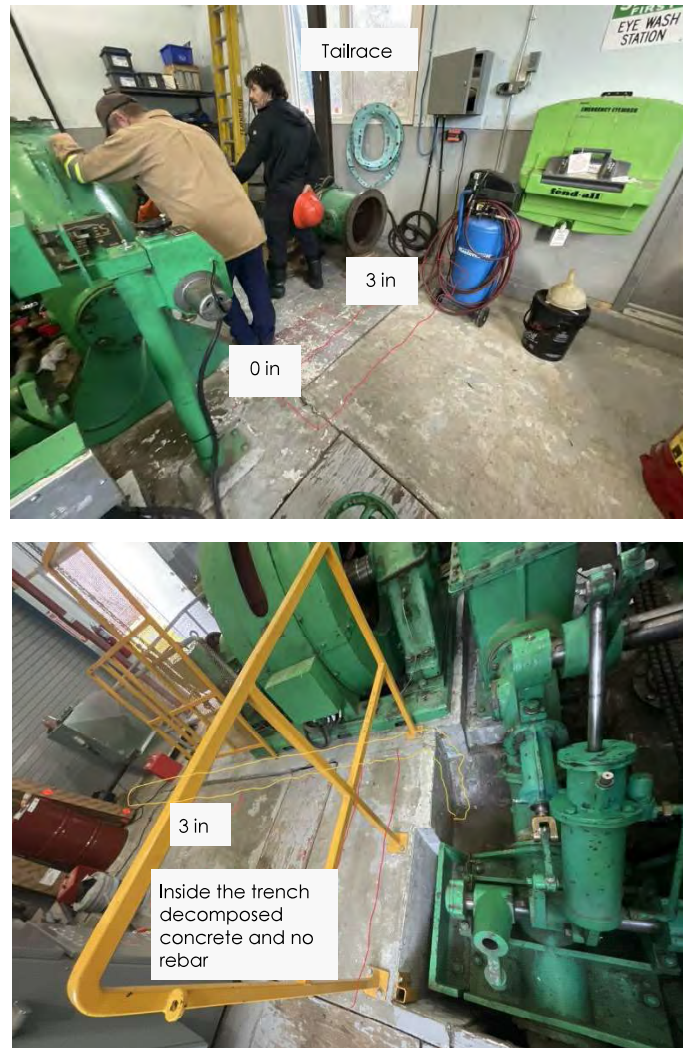
Figure 22: Differential settlement between the concrete block and slab on grade

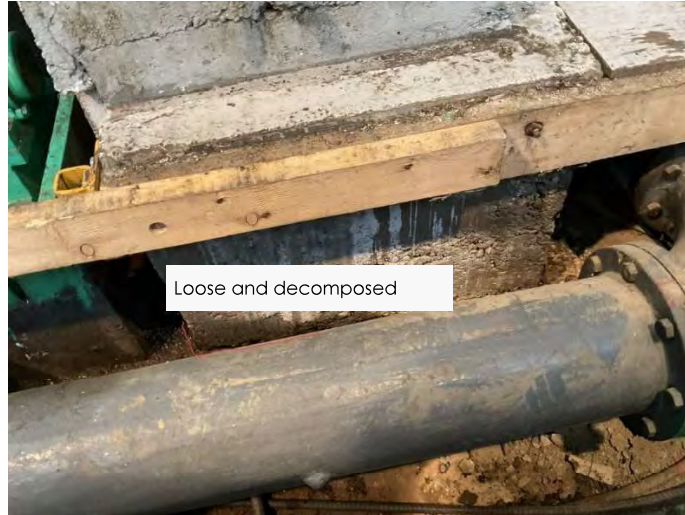
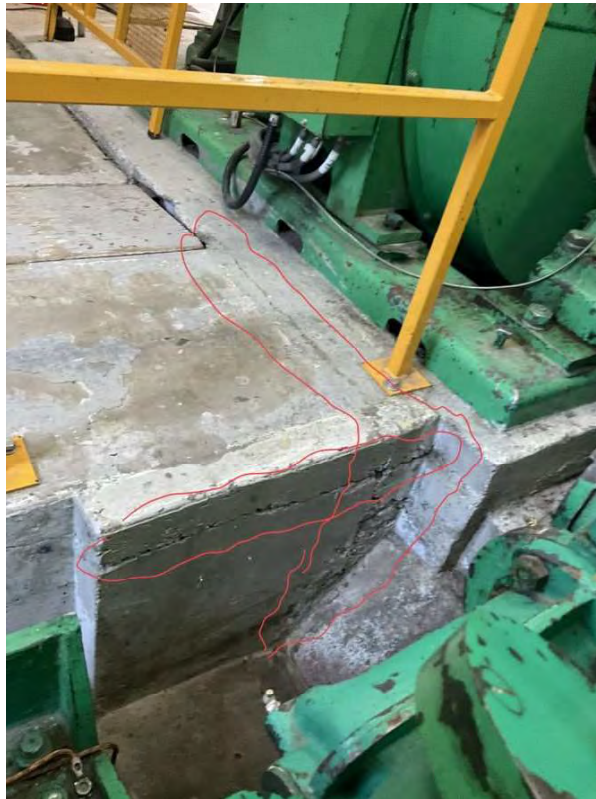
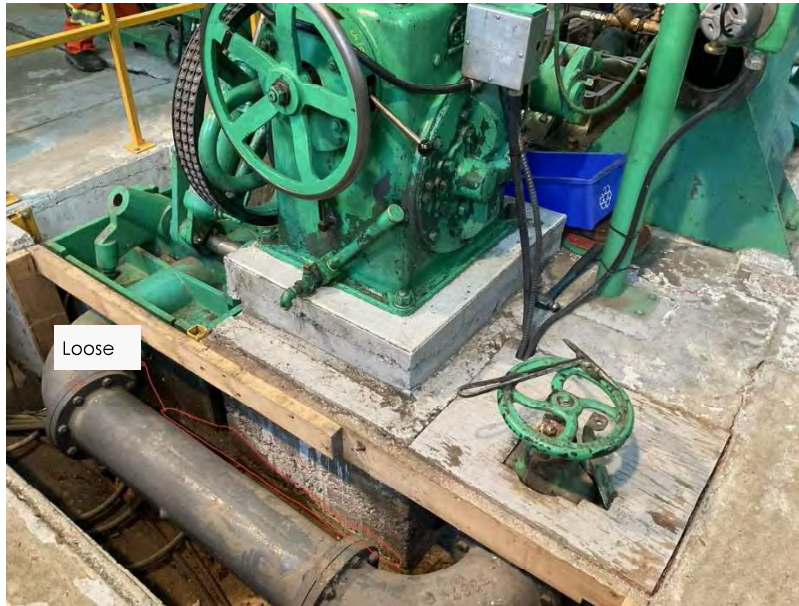
Figure 23: Loose and degraded concrete under the block concrete and inside the trench

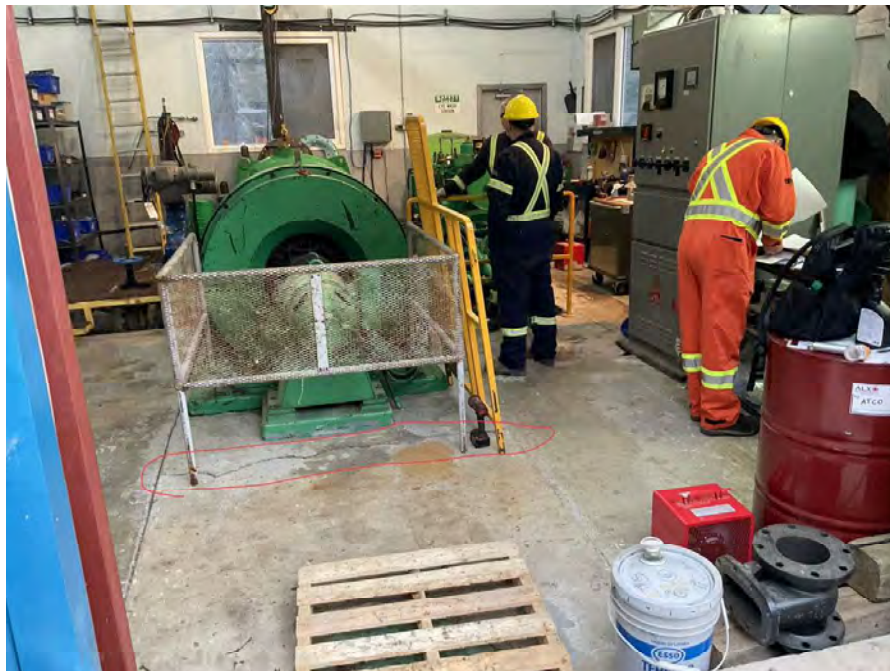
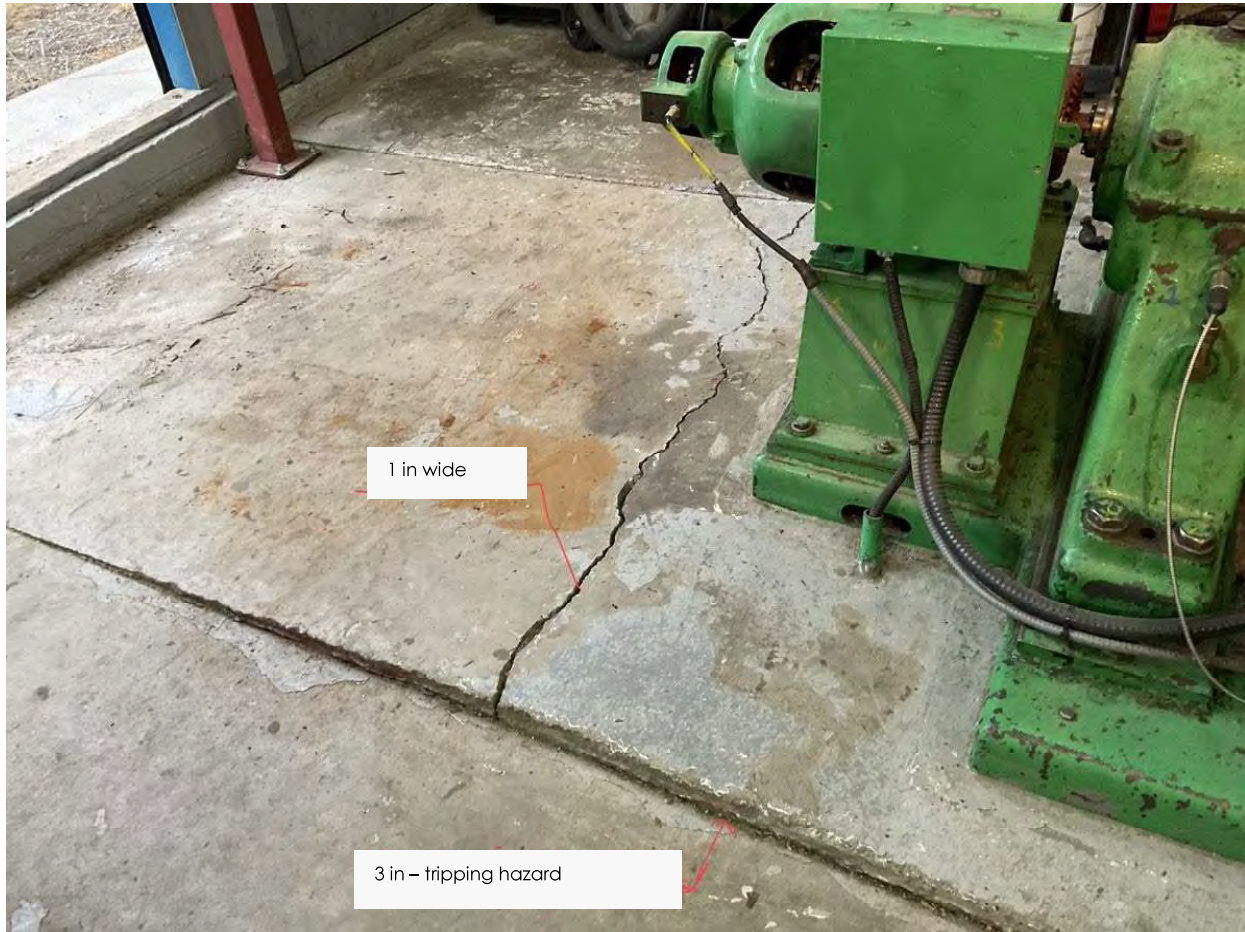
Figure 24: 1 in wide crack on the floor and settlement between the block concrete and building slab

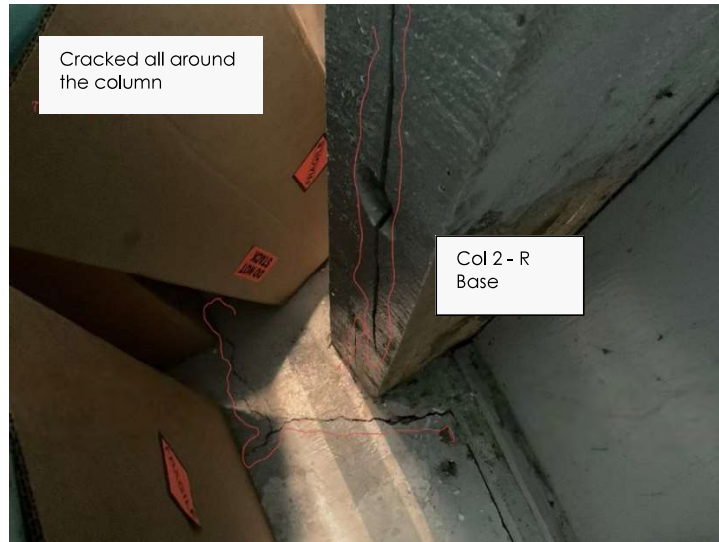
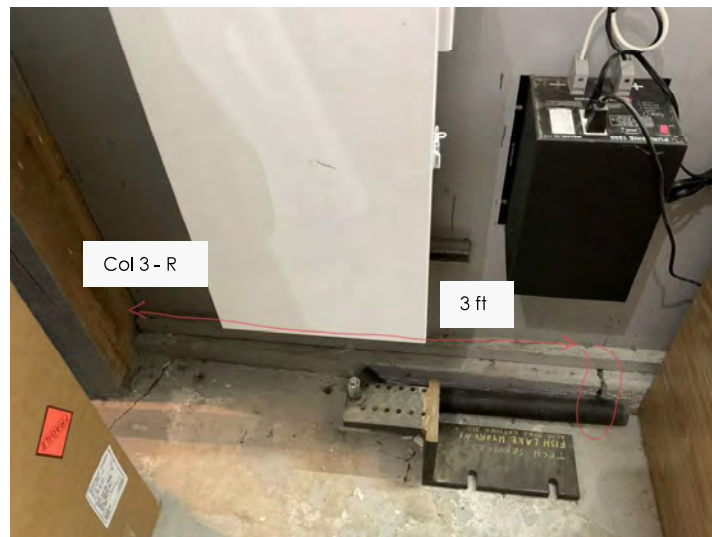
Figure 25: several cracks on the pony walls and column bases

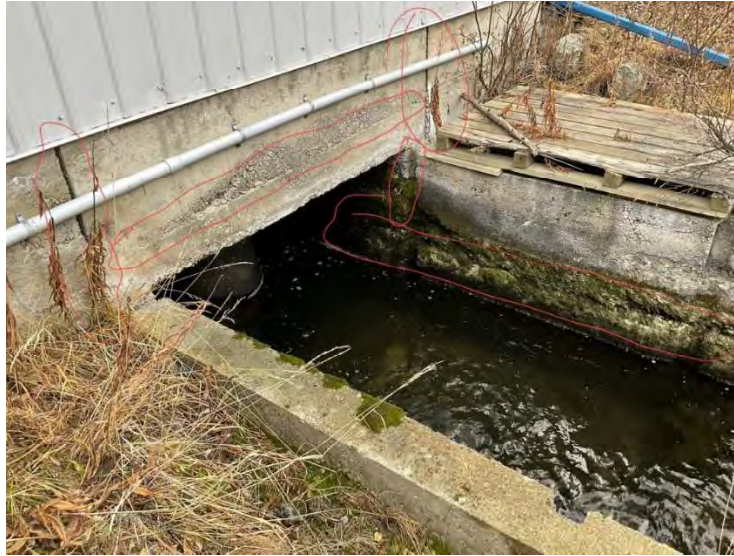
Figure 26: degraded concrete on tailrace walls

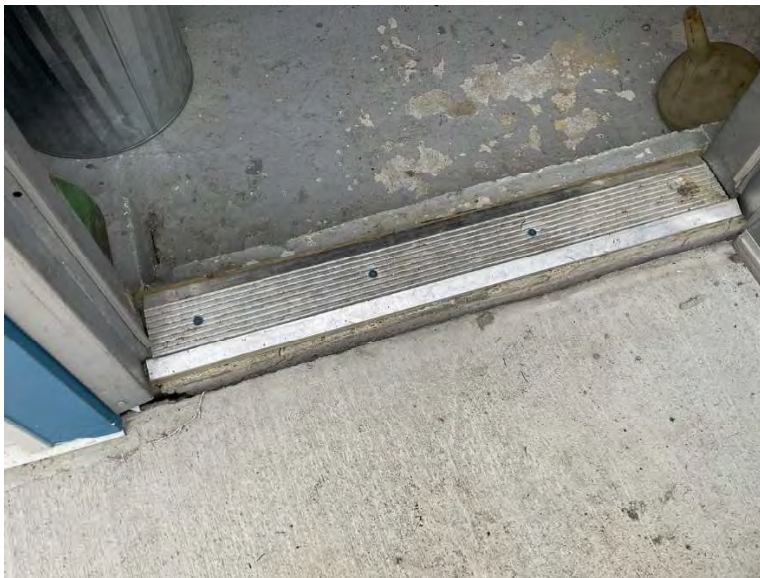
Figure 27: Differential settlement outside and inside the building
