Fish Lake 2 Power Station Design

2023-2024 Business Case #39

ATCO Electric Yukon
Fish Lake 2 Condition Assessment
Fish Lake, YT

Technical Report
Condition Assessment and Options Analysis

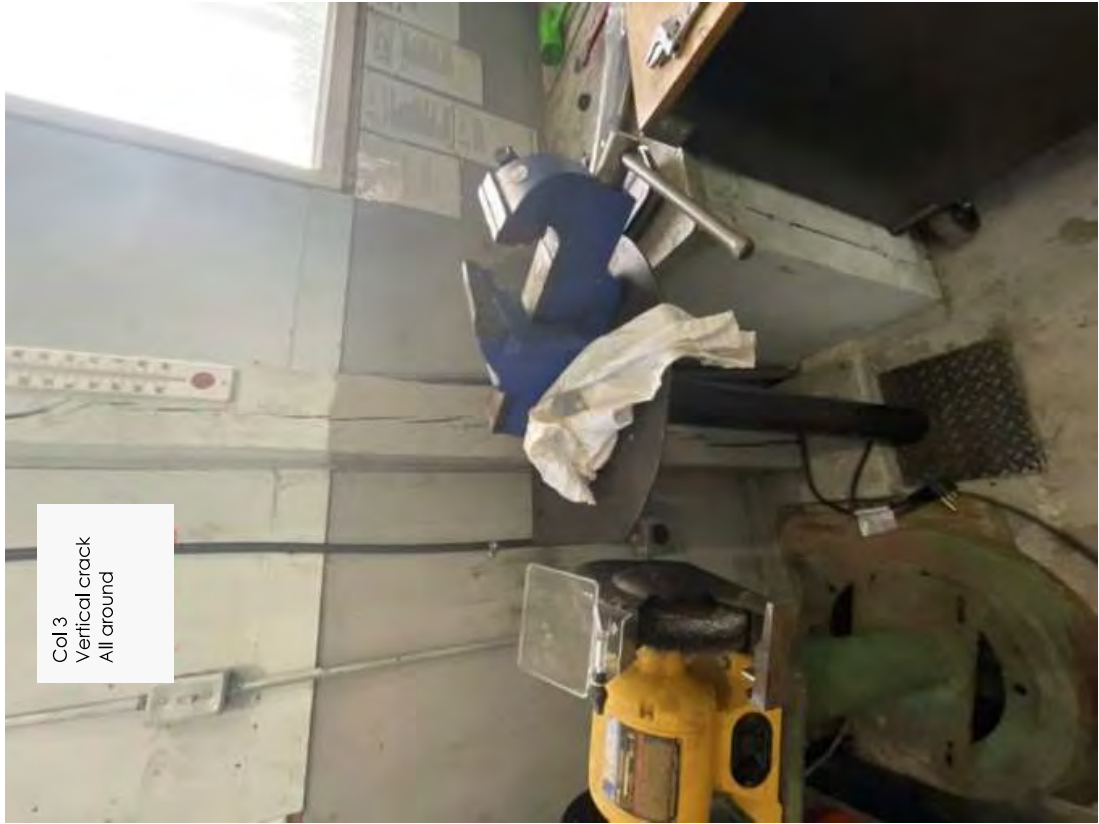
Col3
Vertical crack
All around

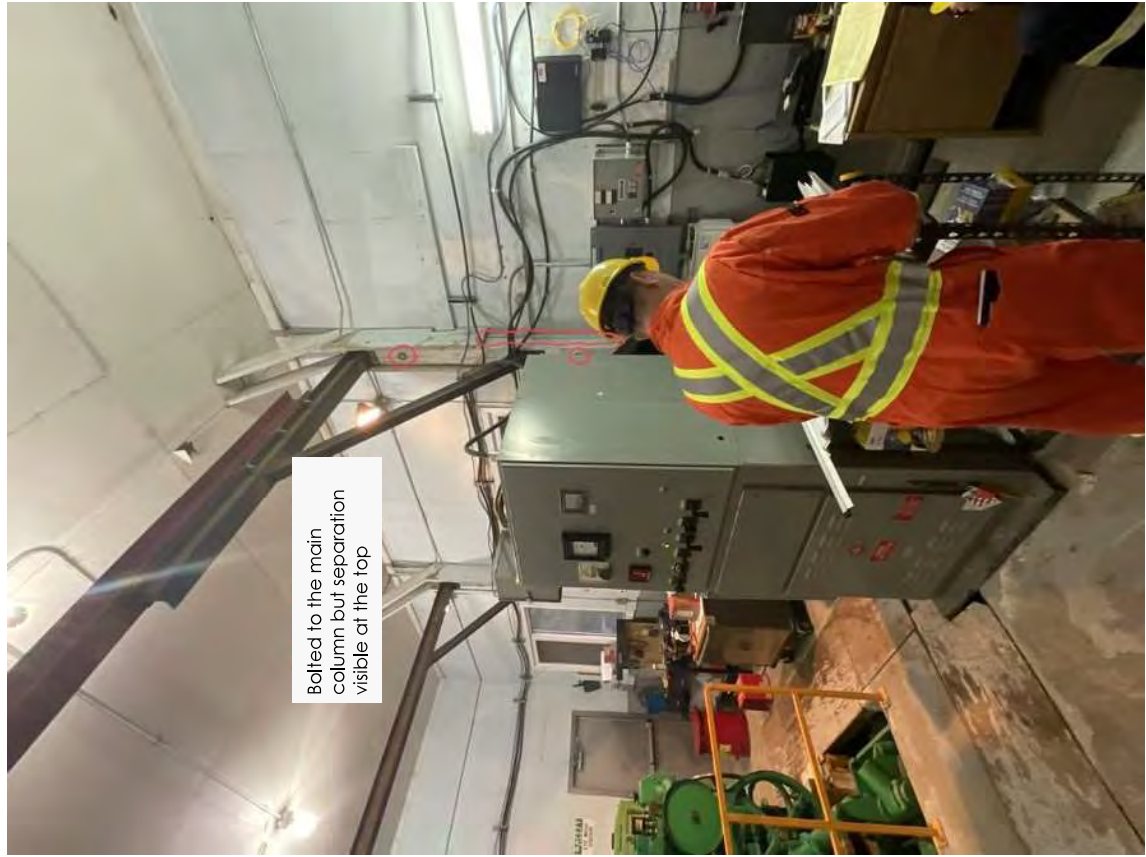
Bolted to the main column but separation visible at the top

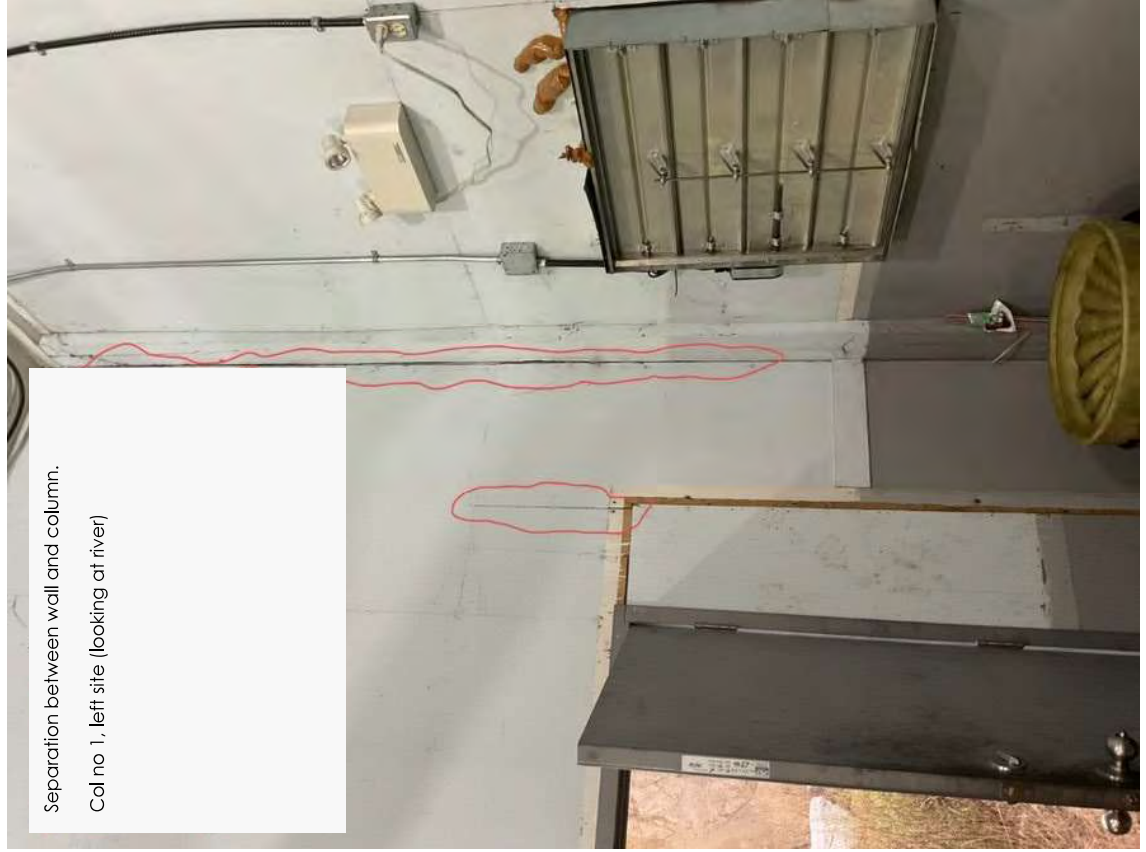
Separation between wall and column.
Col no 1, left site (looking at river)

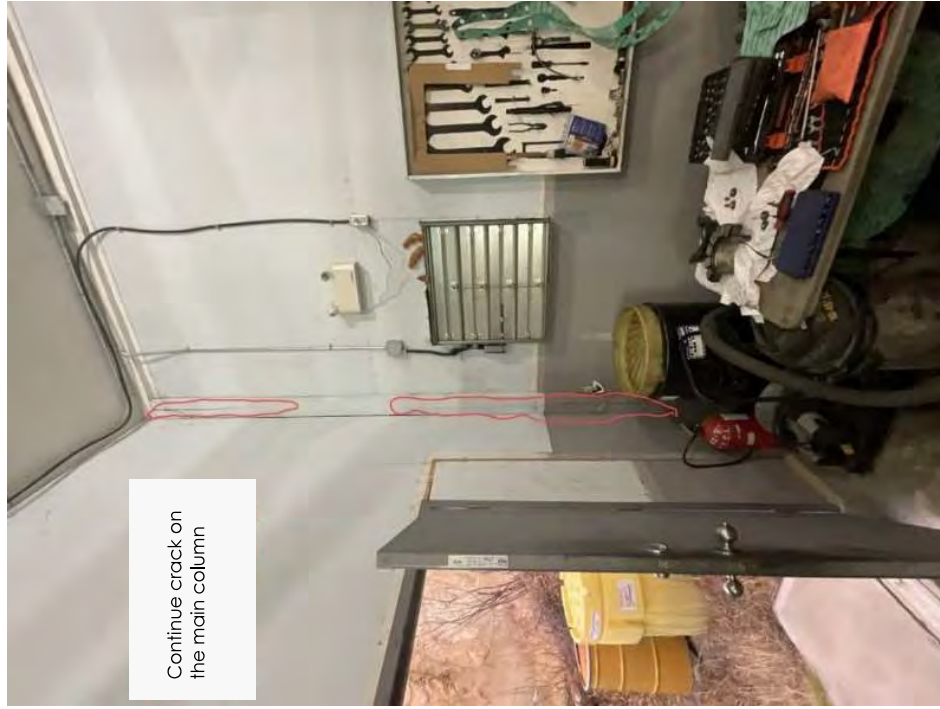
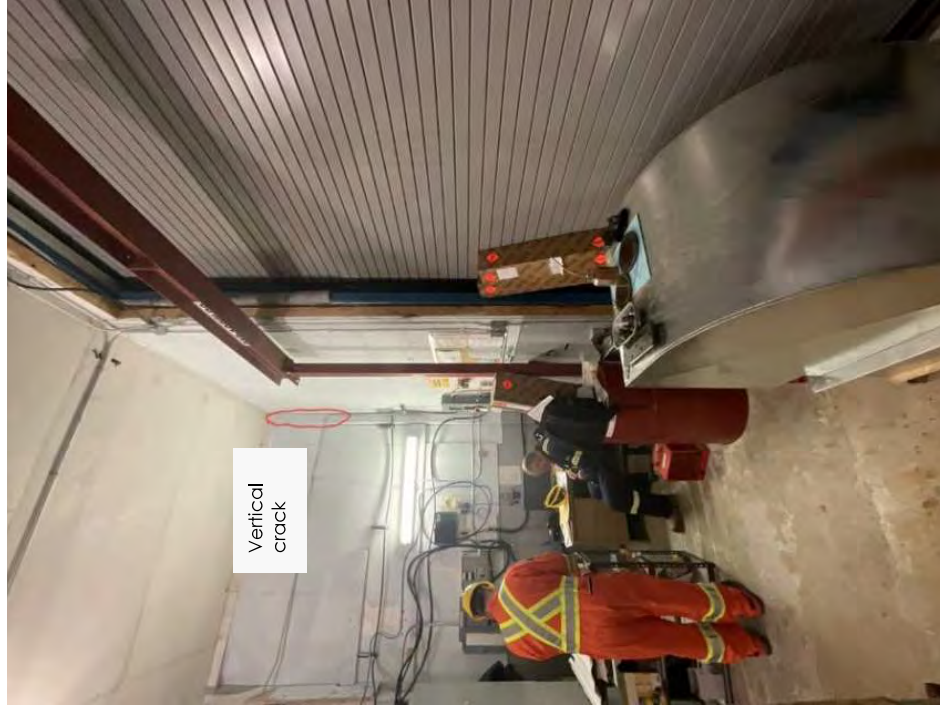
Several cracks were observed on the floor on and around the monorail columns (see Figure 28).

The general visual inspection of the visible structural elements shows that the wooden structure is not in fair condition. The wooden structure is not expected to have any lateral capacity during any seismic event. These structural elements must be retrofitted or replaced.

Figure 28: Cracks on main columns

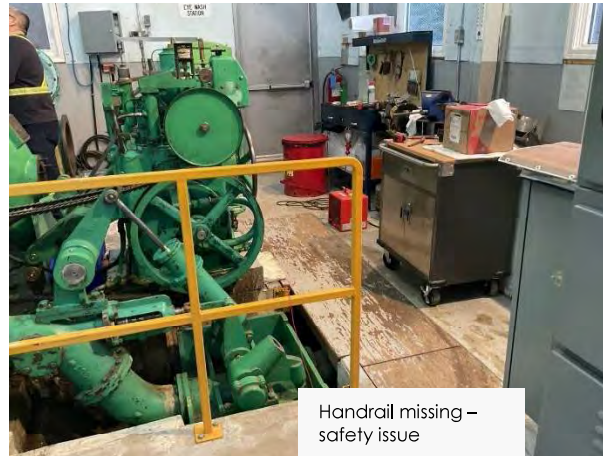
Figure 29: Missing handrails
