Fish Lake 2 Power Station Design

2023-2024 Business Case #39

ATCO Electric Yukon
Fish Lake 2 Condition Assessment
Fish Lake, YT

Technical Report
Condition Assessment and Options Analysis

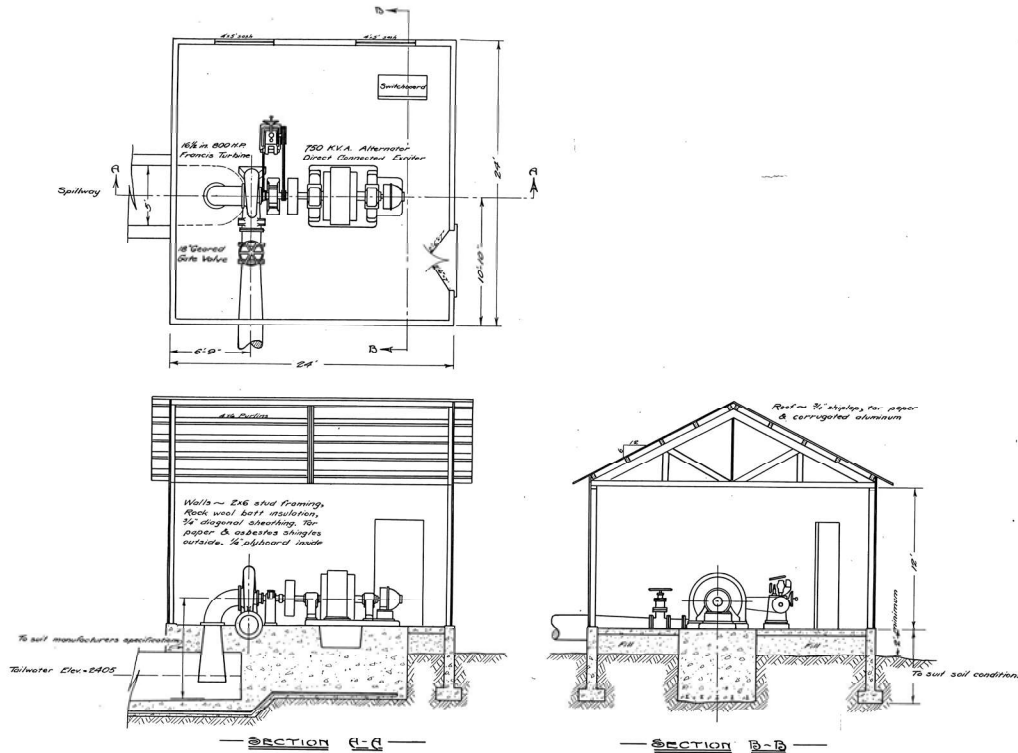
Figure 21: Powerhouse building

The building is a single-storey wooden frame building with wooden roof truss hosting a turbine/generator. The building layout is shown Figure 21 below.

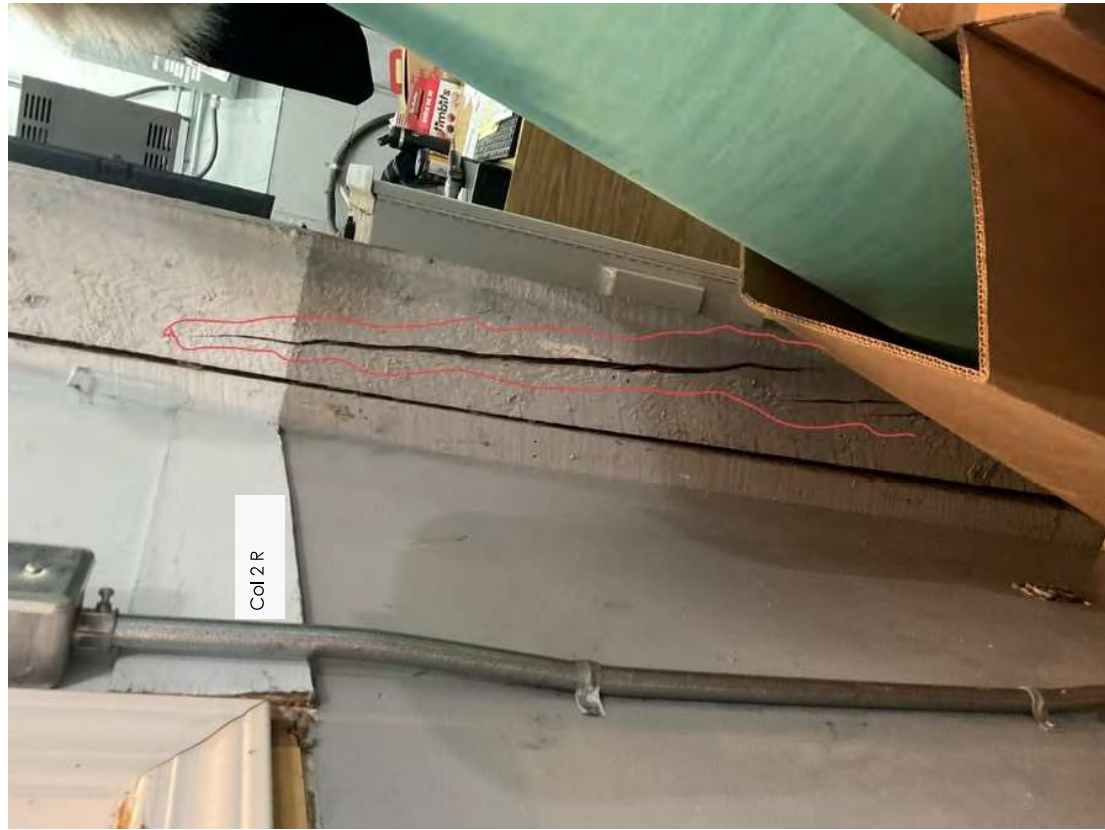
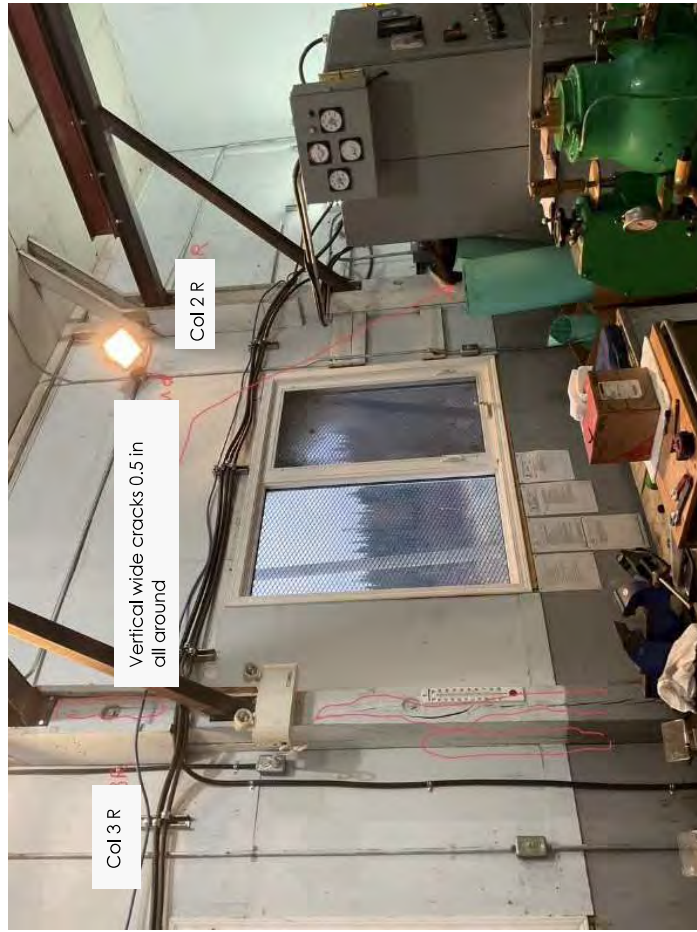
Bolted to the main column but separation visible at the top
